Simple ageless methods for field testing power transformers of no-load condition at the low induced voltage

(Analytical review with the aid of transformer field service technicians) – Part II

3. IEEE practice (excitation current test)

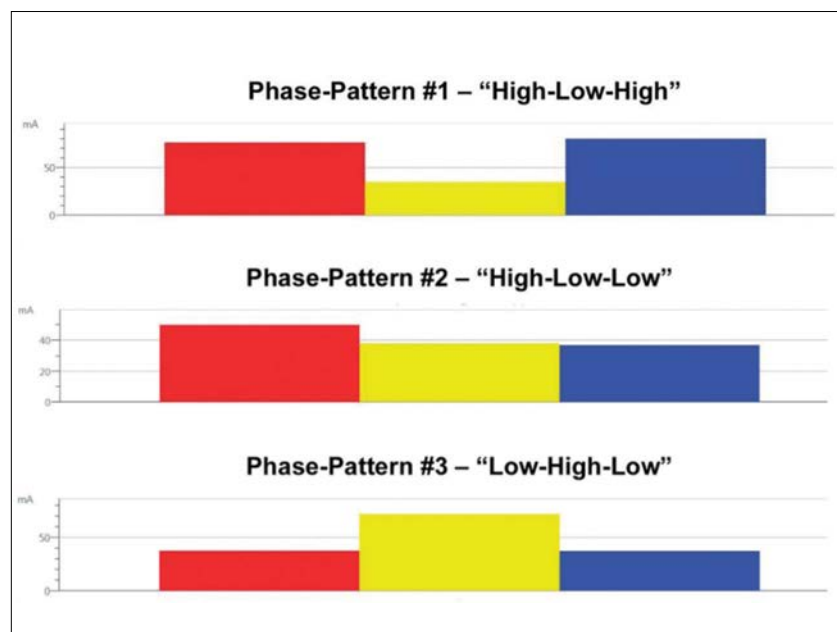
Figure 1. Example of an excitation current phase pattern (figure from OMICRON, explanations in the text)

common. This pattern is also characteristic of a transformer with a five-limb core-form (or shell) with a delta-connected secondary winding (Fig. 1). “High-Low-Low” phase pattern #2 is expected for transformers with a 3-limb core-form design and wye (without accessible neutral) HV winding and with. “Low-High-Low” phase pattern #3 is expected in the following cases: when the power transformer is damaged; when the third terminal on a delta-connect-

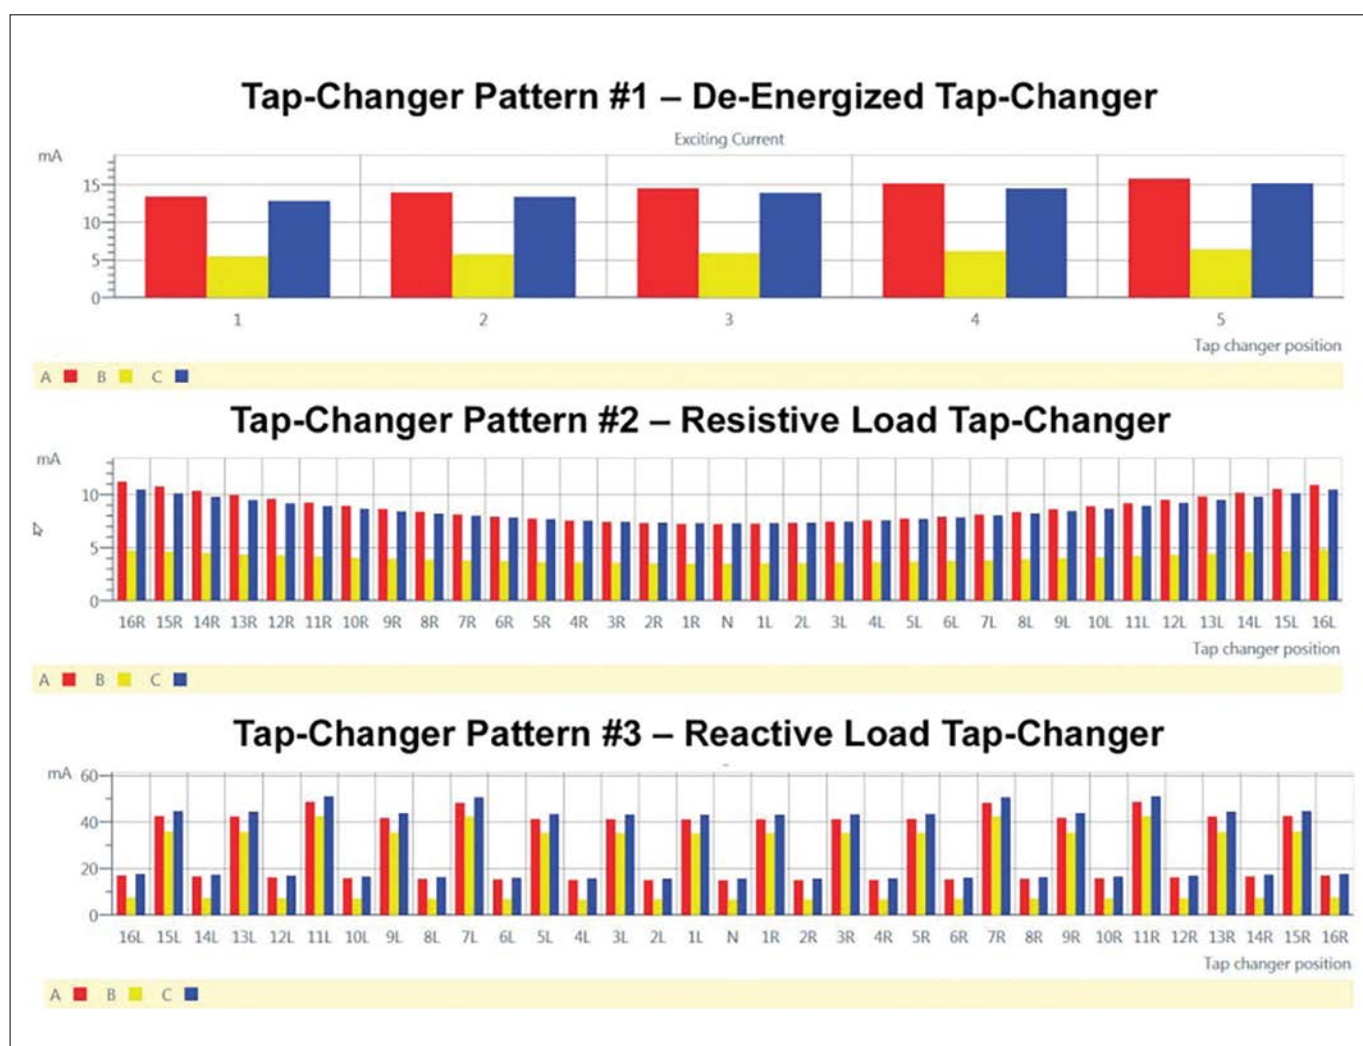
Figure 3. Example of the three tap-changer patterns (figure from OMICRON).

Fig. 3 provides an example of these three tap-changer patterns.
